THIS DEBRIS MATTERS:
PRESERVING FIRE-DAMAGED HISTORIC BUILDINGS

Thesis submitted to the Faculty of Goucher College in partial
fulfillment of the requirements for the degree of
Master of Arts in Historic Preservation
2013

CHAPTER IV PROVO TABERNACLE CASE STUDY

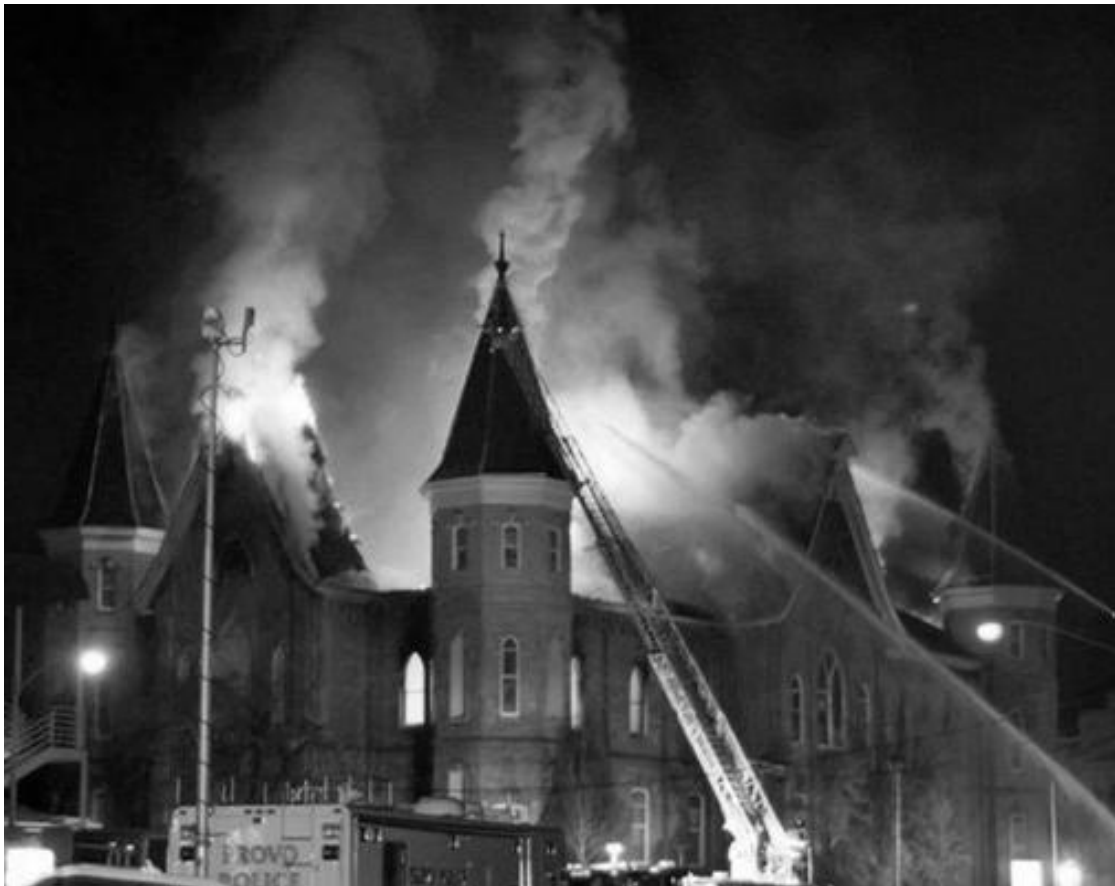
Because the fire started in the attic and burned through the king truss, the entire roof collapsed within the exterior walls only a few hours after the first firefighters arrived on scene. Due to the collapsed roof and other debris confined within the masonry exterior walls, the building continued to burn for another 48 hours. This meant that little of the building's interior walls or finishes survived. Every surface in the building was affected by combustion, smoke, or water (See Figure 3).

Figure 3: Provo Tabernacle on Fire, December 17, 2010. [Image courtesy LDS Church History Department.]

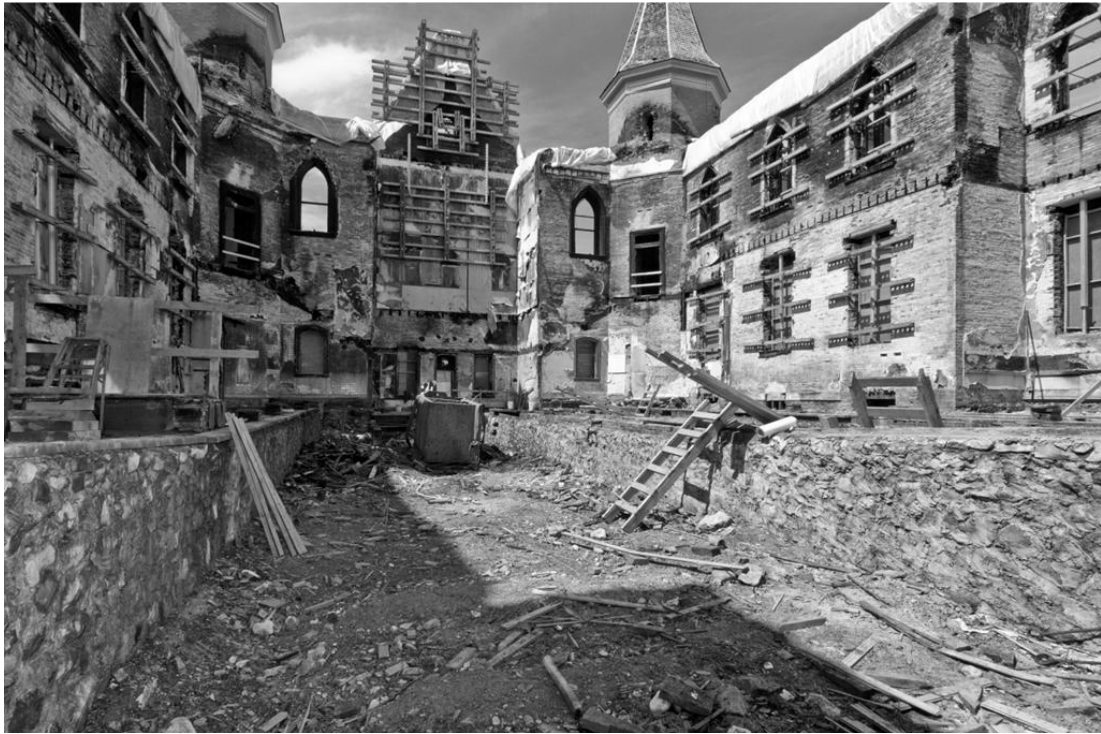
Two questions guided the next few months of work on the project: Were the exterior walls stable? Did any character defining elements on the building's interior survive the fire? Portions of the exterior masonry bearing walls collapsed as the roof separated from the walls but overall they were stable and in good condition. Some projecting sandstone courses were broken off by falling building debris and some brick was smoke and soot stained. The exterior walls were structurally braced with steel as a precautionary measure (See Figure 4).

The interior of the building was a far different story. Most of the building had burned and collapsed into an at least six-foot deep pile debris. This debris mixed with the water used to fight the fire then froze in the frigid December weather. Most of the interior plaster separated from the walls. Many wood lintels above doors and windows were completely destroyed. The balcony burned completely, leaving only beam pockets along the exterior walls. Most of the cast iron columns supporting the inside edge of the balcony remained standing. All of the rooms under the front stage area were damaged. Every interior surface, if not charred, was damaged by smoke and water. Because all of the surviving interior finishes were buried under several feet of debris and ice there was little priority in putting a temporary roof on the structure.

Figure 4: Provo Tabernacle Interior, March 2011. Note the steel bracing at almost all of the window openings. Most of the plaster was destroyed in the fire and most headers were also destroyed. The floor was partially removed in anticipation of construction of a new full height basement instead of the pre-fire crawlspace. Plastic sheeting was placed over the tops of masonry walls to protect them from further deterioration after the roof collapse. [Image courtesy LDS Church History Department.]
