THIS DEBRIS MATTERS:
PRESERVING FIRE-DAMAGED HISTORIC BUILDINGS

Thesis submitted to the Faculty of Goucher College in partial
fulfillment of the requirements for the degree of
Master of Arts in Historic Preservation
2013

CHAPTER IV PROVO TABERNACLE CASE STUDY

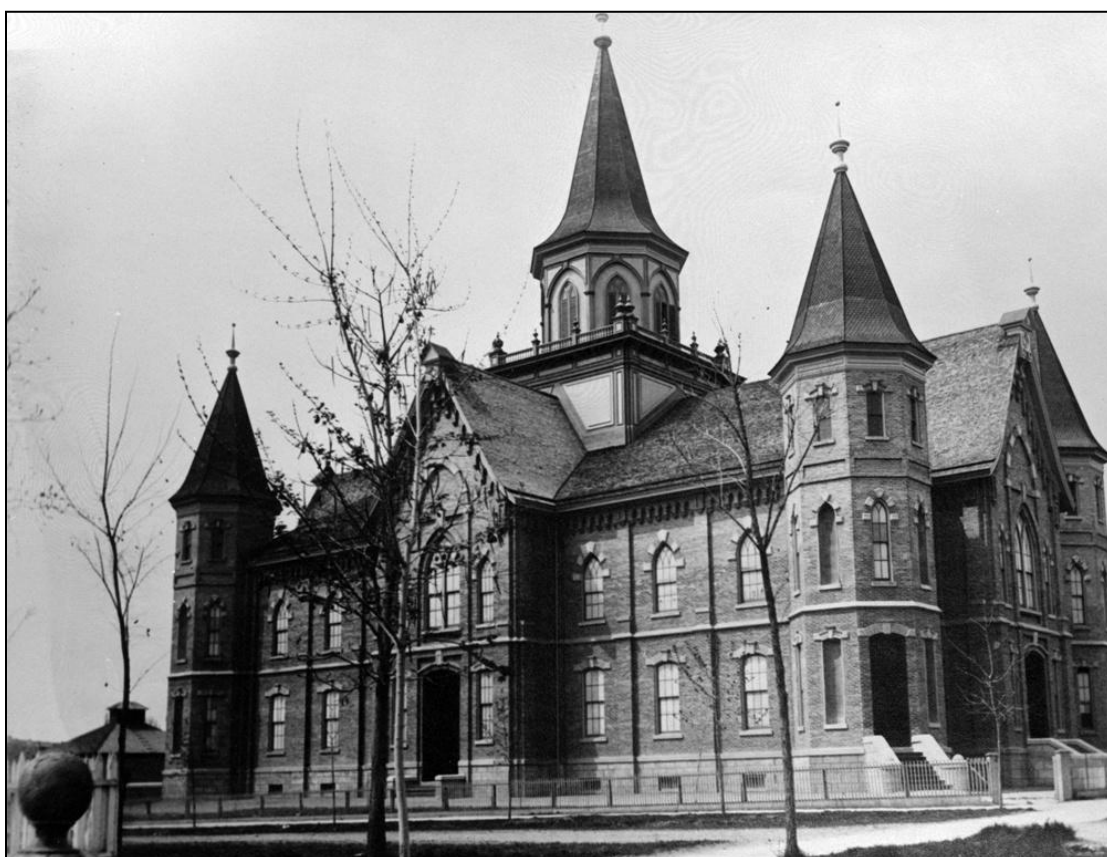
The building had been renovated several times since its completion. Its large exterior center tower (see Figure 1) was removed in phases between 1907 and 1917 because of structural concerns. Art glass windows replaced clear glass windows around

Figure 1: Provo Tabernacle Exterior, circa 1900. The center tower was removed in phases between 1907 and 1918 because of structural concerns. [Image courtesy LDS Church History Department.]

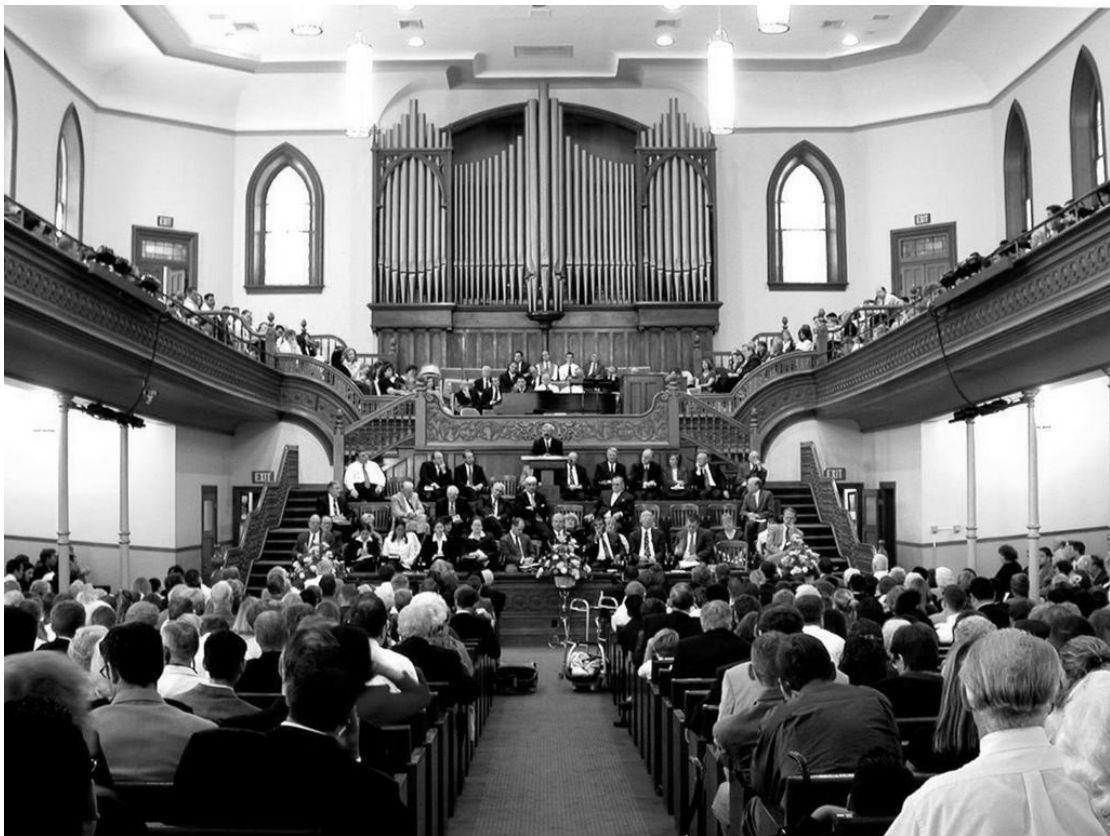
Figure 2: Provo Tabernacle Interior in 2006. Note the pipe organ installed in 1907. Other renovations apparent in the photograph include small meeting rooms to the sides of the rostrum, widening of the rostrum stair case, and a decorative carved panel behind the pulpit. [Image courtesy LDS Church History Department.]

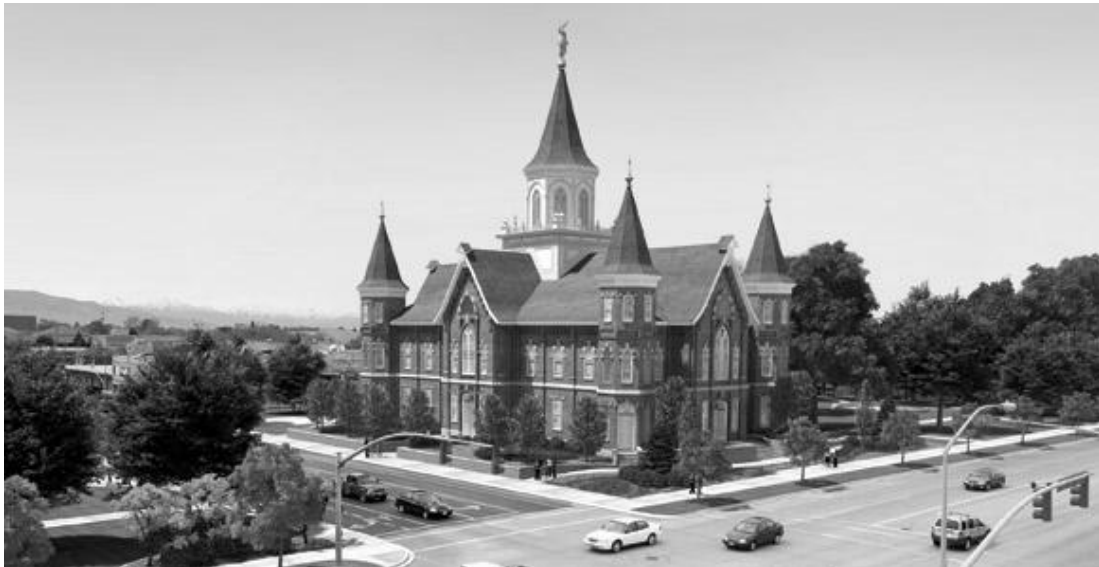
Figure 5: Rendering of the Provo City Center Temple. The center tower will be reconstructed. Paint colors and materials for the new roof were being finalized at the time of treatise completion. [Image courtesy LDS Church Special Projects Department.]

At the time of this writing in 2013, construction at the site had just begun. The design team intends for the building to retain its National Register status but the success of that endeavor will not be known until the project is completed in about 2015. At that time an addendum to the original National Register nomination will be submitted. The exterior walls will remain standing with a seismic upgrade located on the inside so as to retain original exterior integrity. The art glass windows will be restored or replicated and the roof reconstructed to its 1898 appearance with a center tower (see Figure 5).
